Roadway Departure Crashes, Guardrail End Treatment Issues, and “Frankensteined” Guardrail

By Seth Chalmers, PE
Director of Traffic Engineering

January 9, 2024

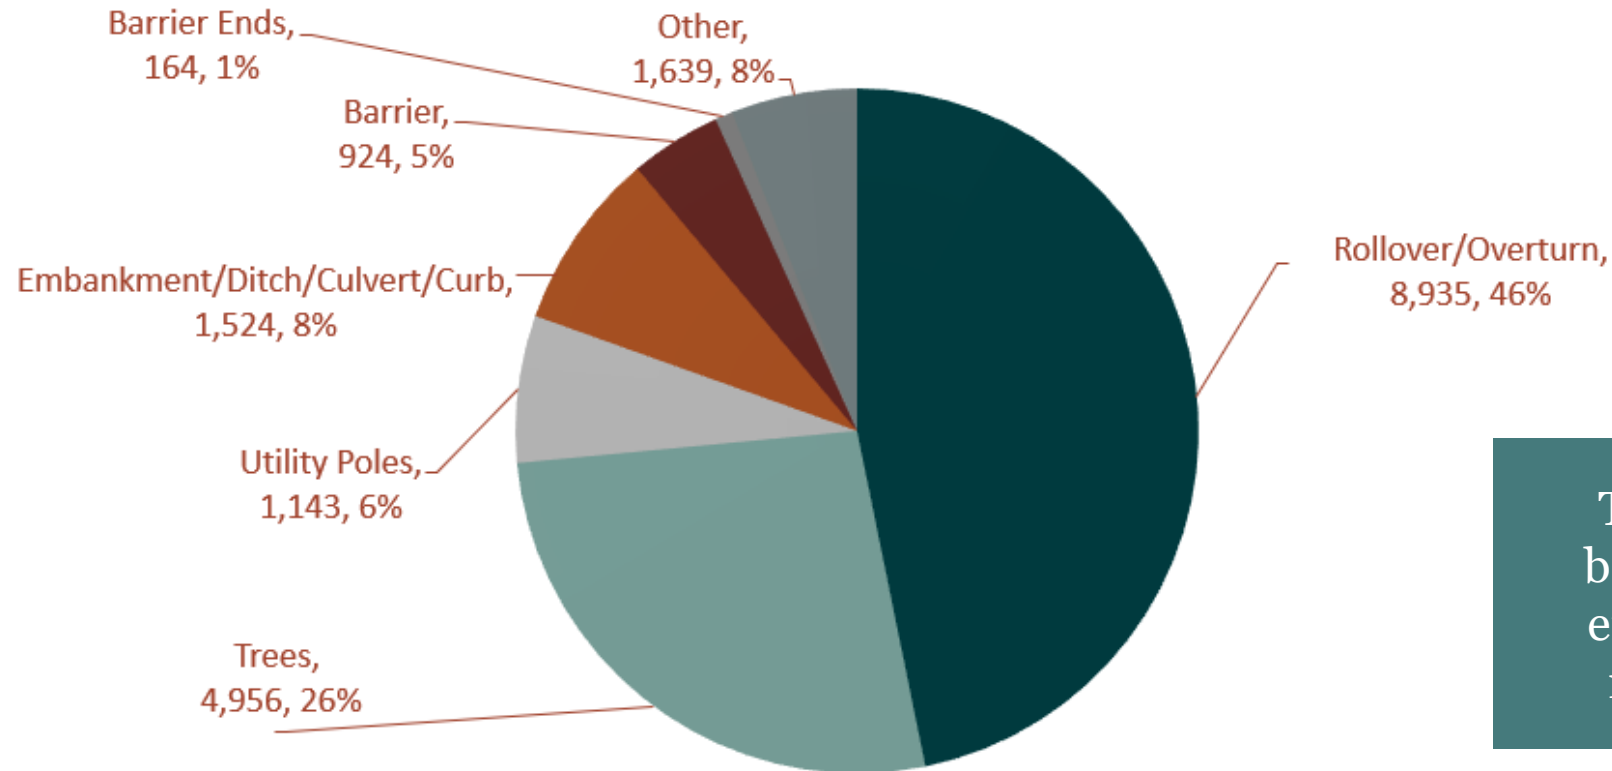
Total RwD Fatalities

Single Vehicle Fatal Crashes (2016) – 19,285

Total attributed to barriers and barrier ends is 1,088, 6% – mostly guardrails

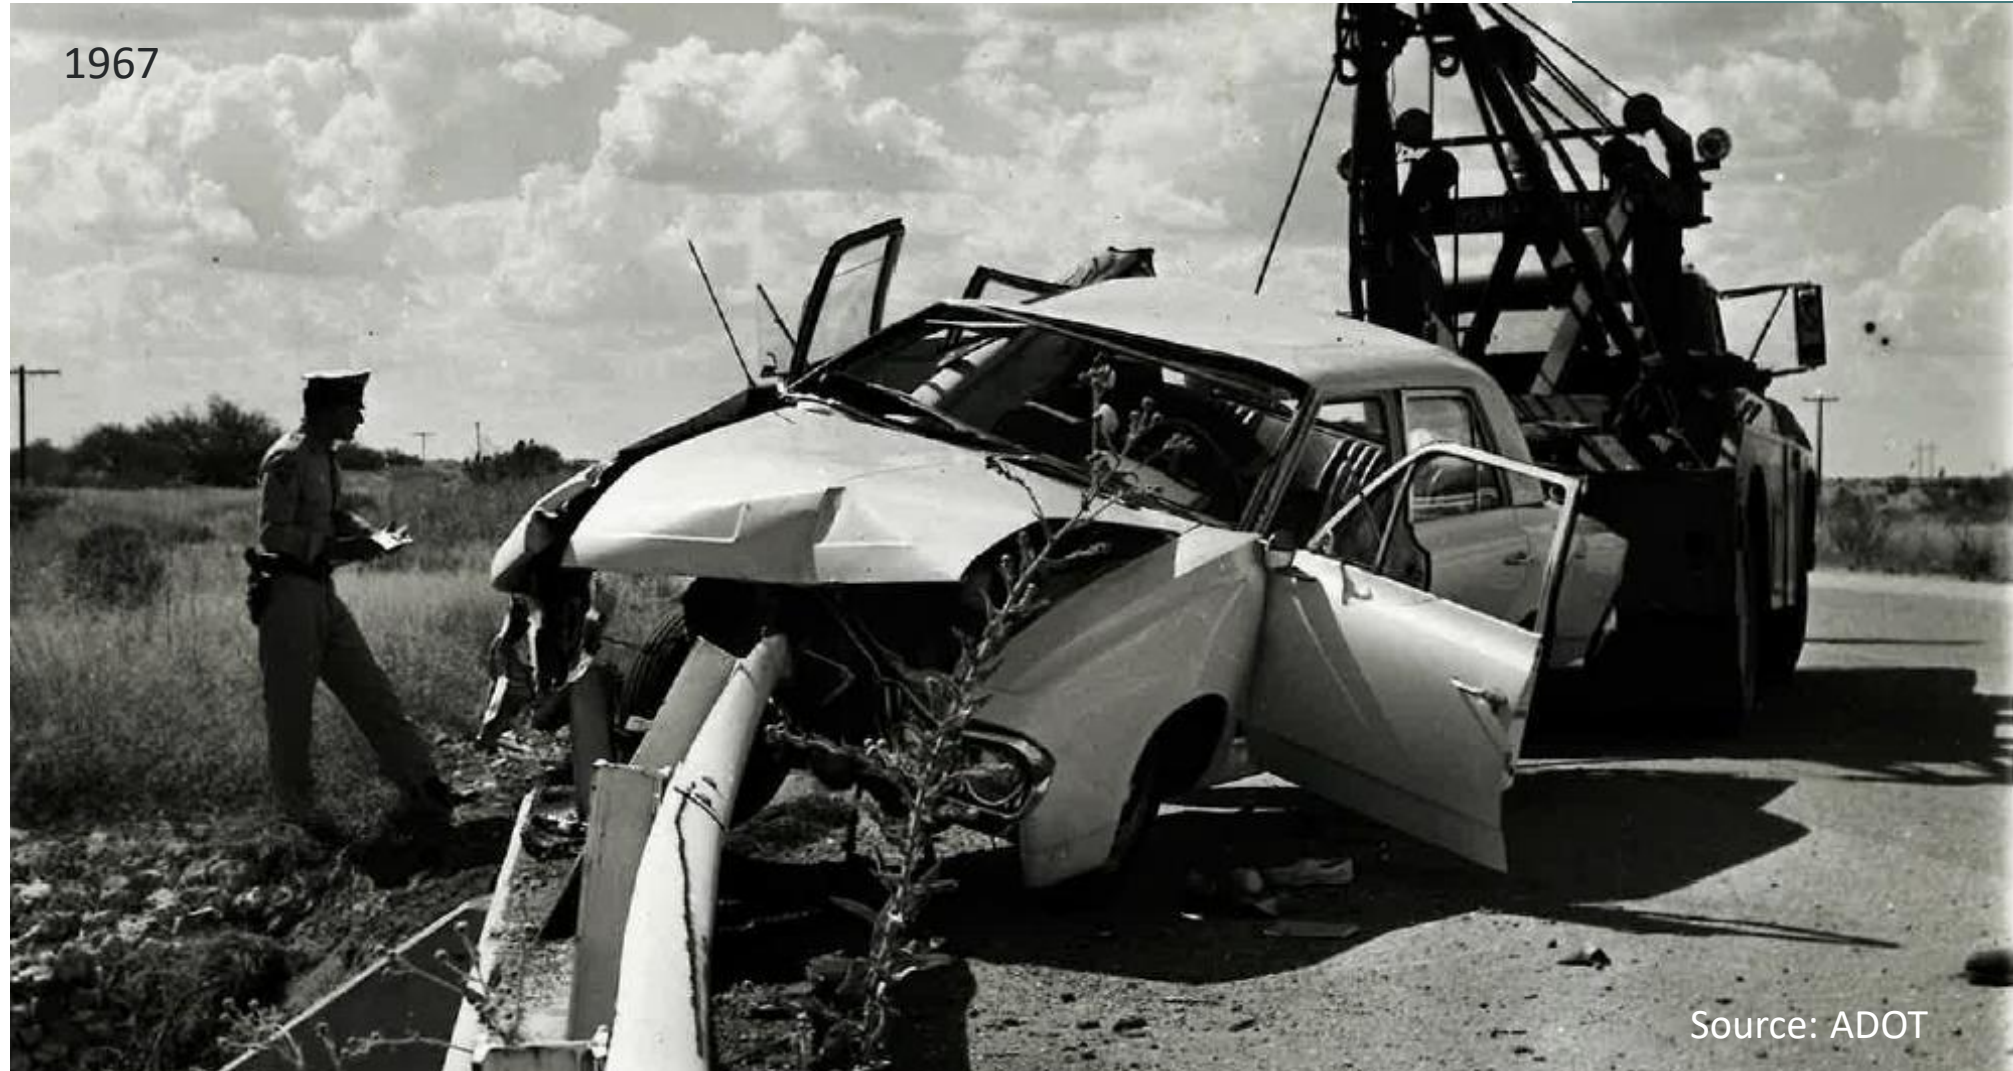
I-10 west of Benson, AZ, on September 13, 1967. The passenger, Elsa Ann Walton, age 21, was killed after her husband crashed the car. Guardrail tragedies have been a part of American life for a long time. This guardrail probably did not have a guardrail end treatment (GET). There are still many guardrails in Arizona that do not have modern GETs, are functionally obsolete, have not been installed correctly, or have not been maintained/repared as needed. This is unacceptable.

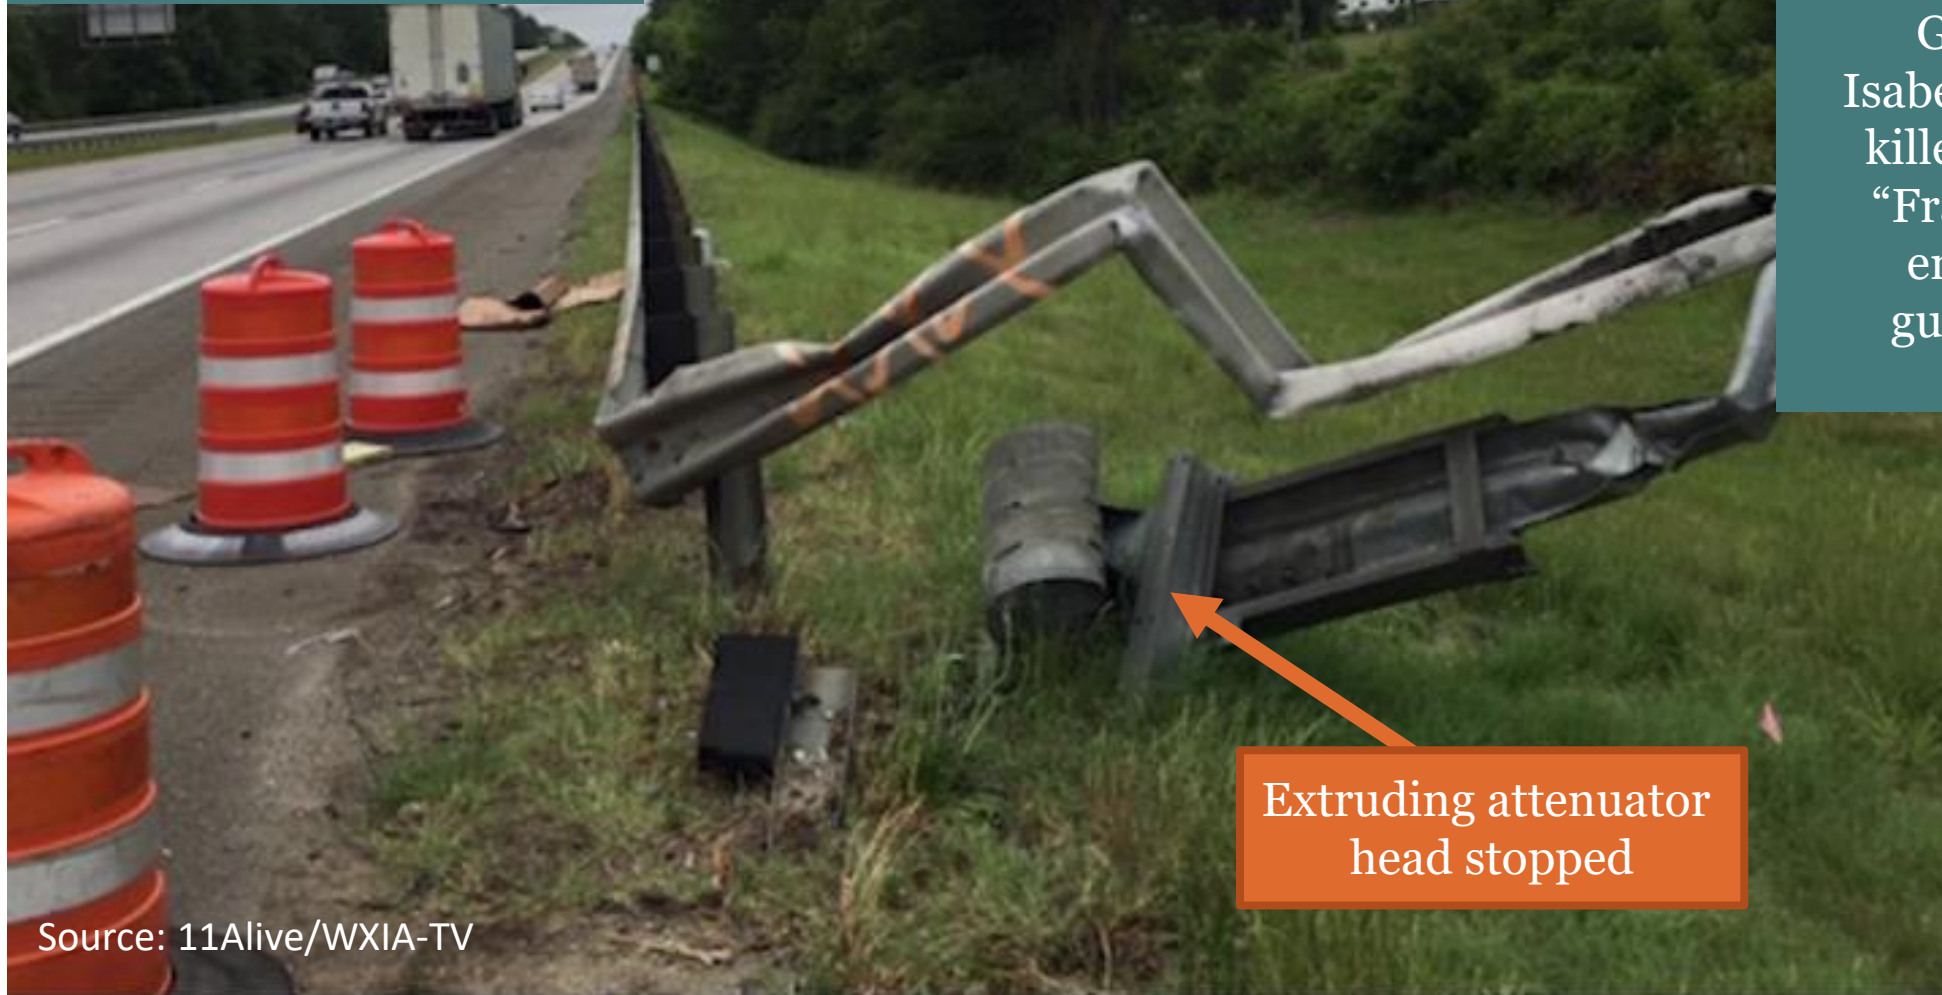
“Frankensteined” GETs

Georgia teen, Isabella Alonzo, was killed in 2020 in a “Frankensteined” end treatment guardrail crash.

Extruding attenuator head stopped

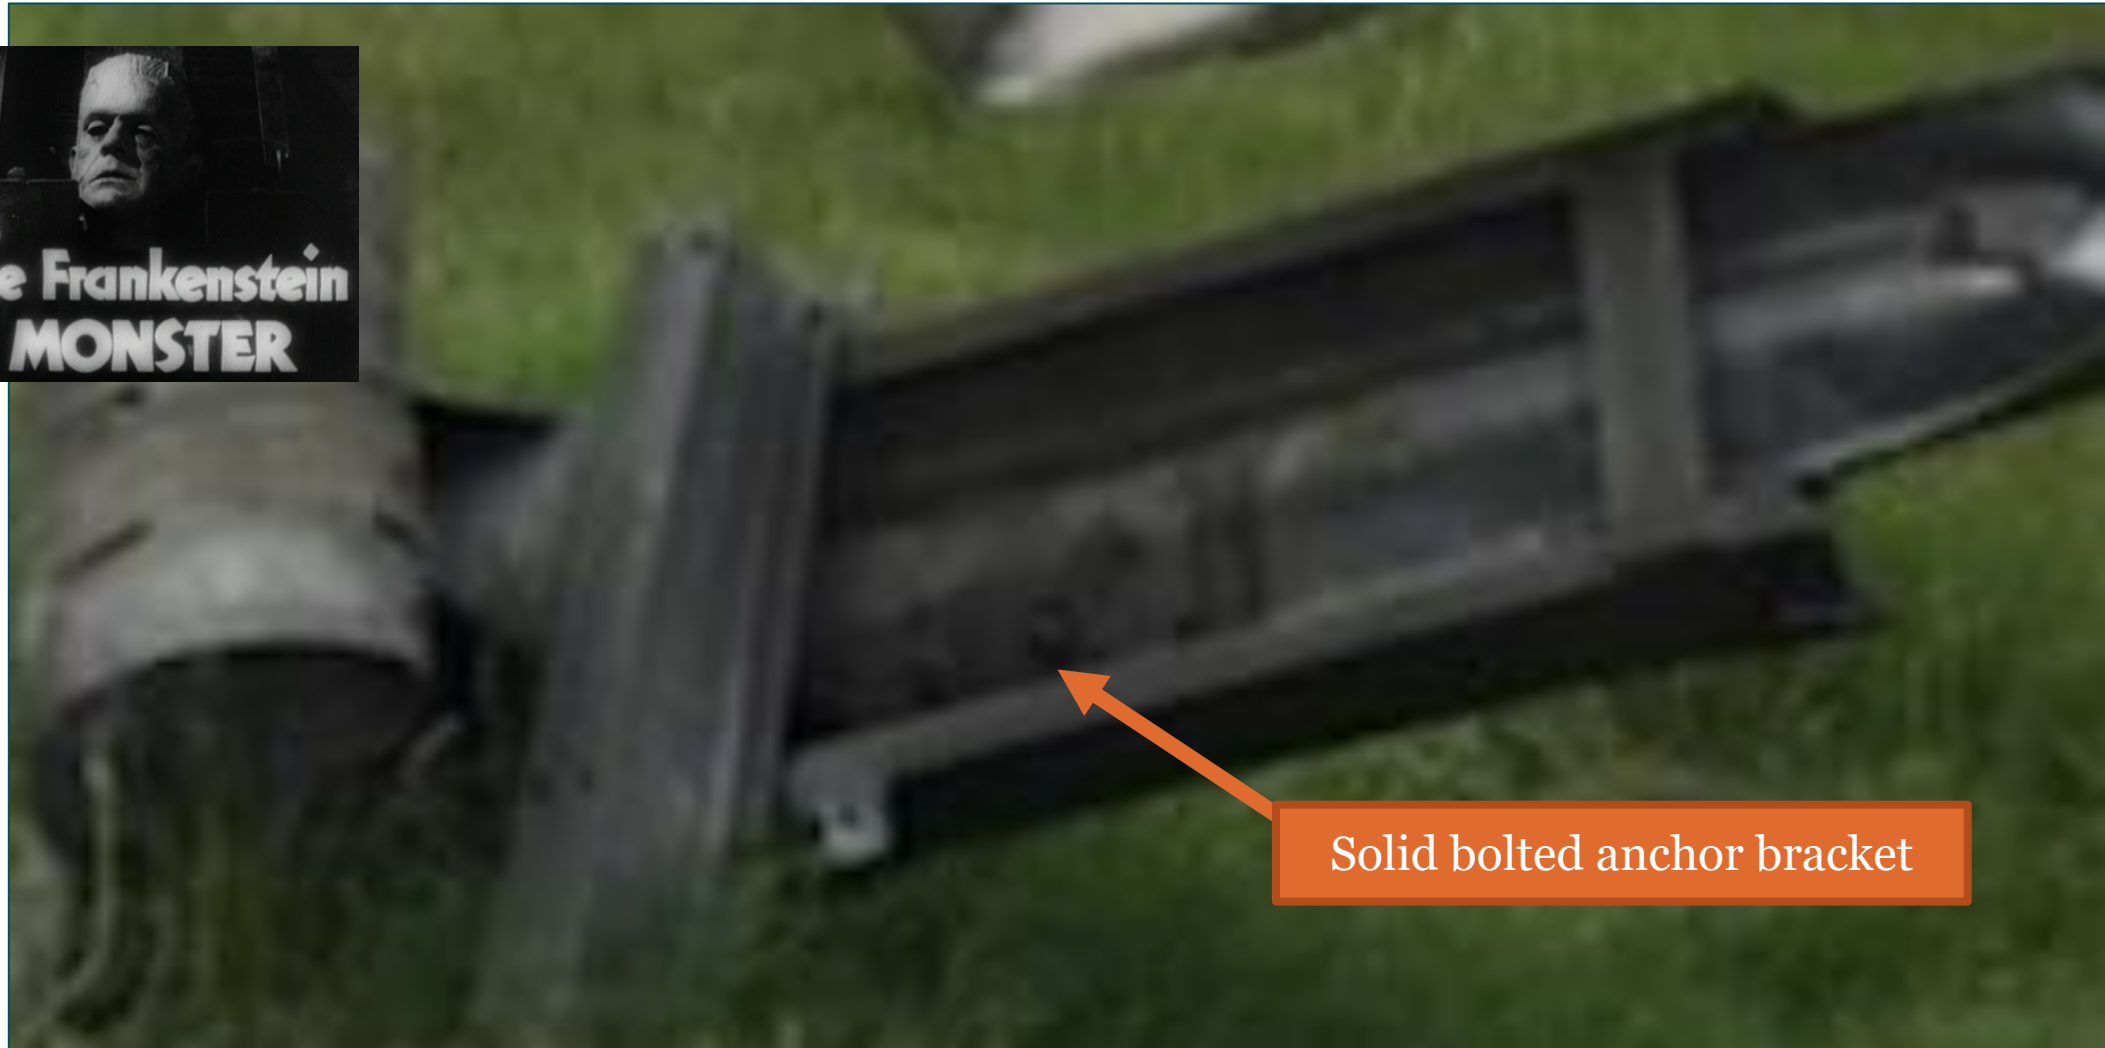
Solid bolted anchor bracket

The key issue appears to be with the cable anchor rail connected tension bracket.

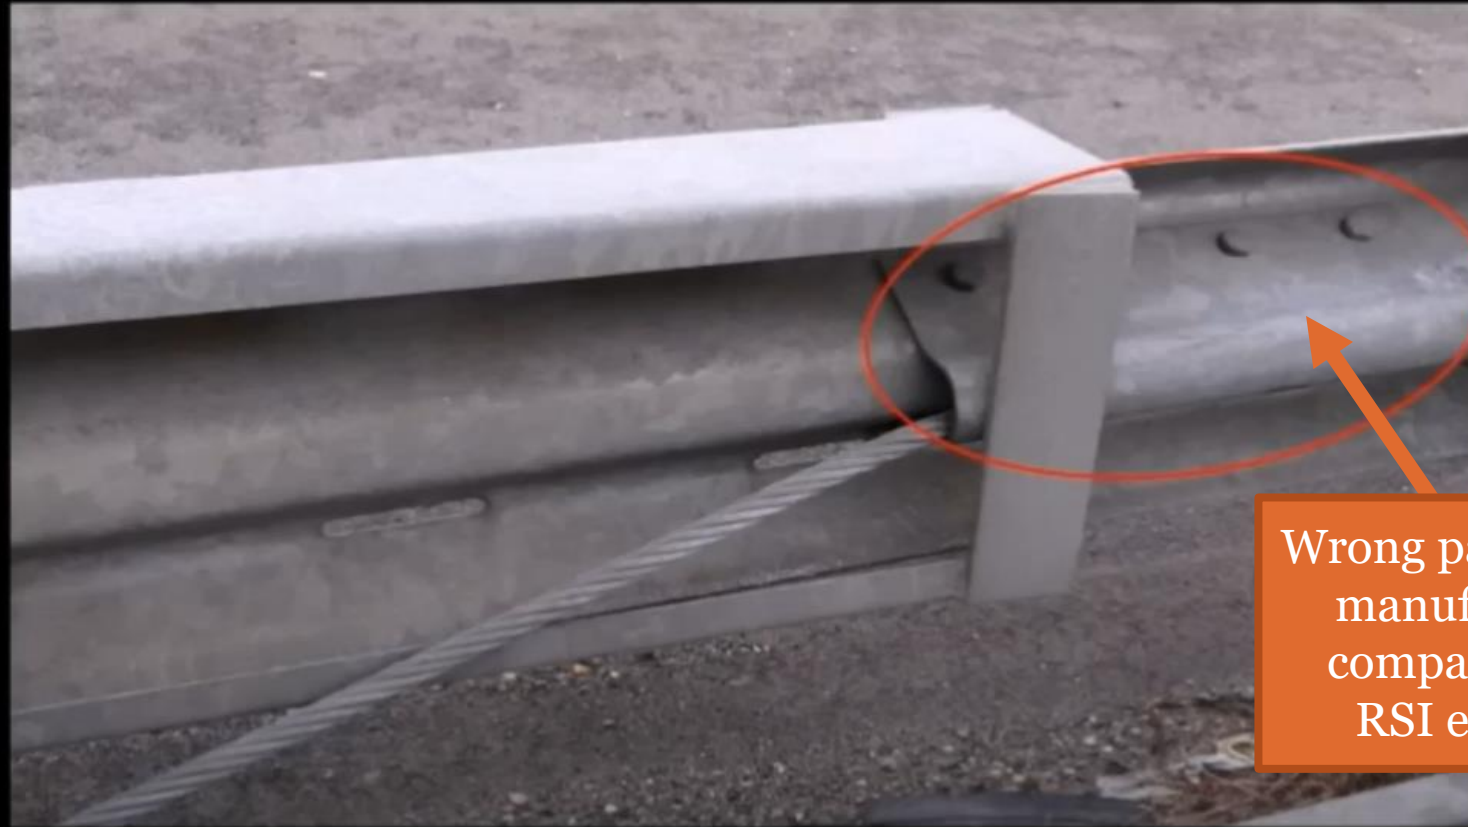
Wrong part from another manufacturer – not compatible with this RSI extruder head

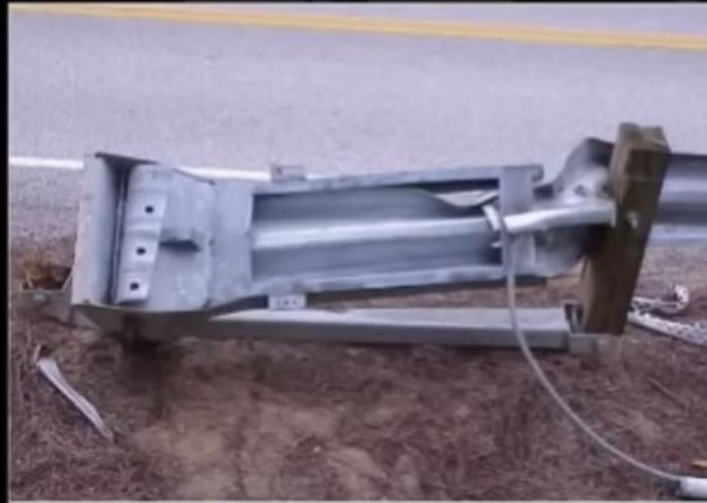
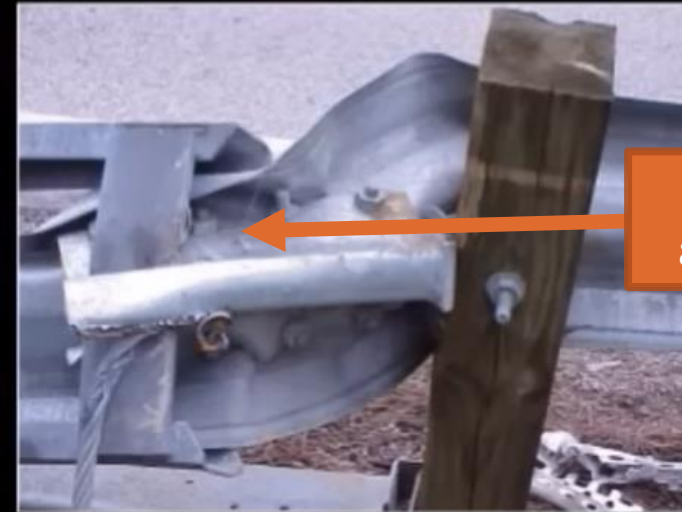
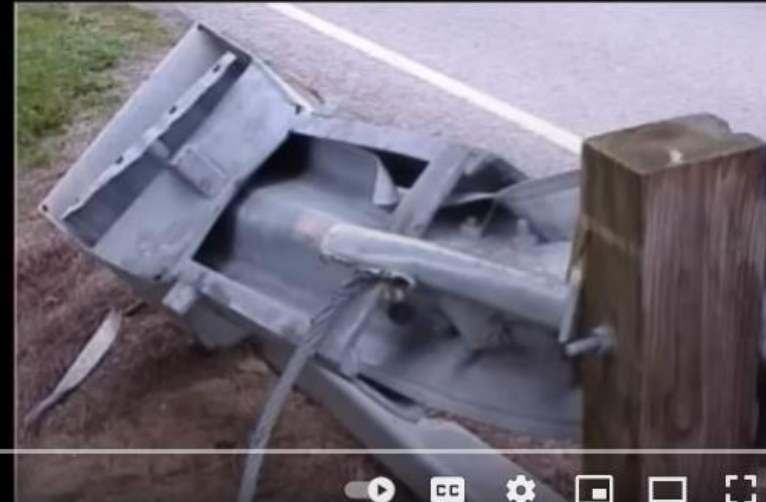
The Consequences of a Solid Bolted Anchor Bracket

Solid bolted
anchor bracket

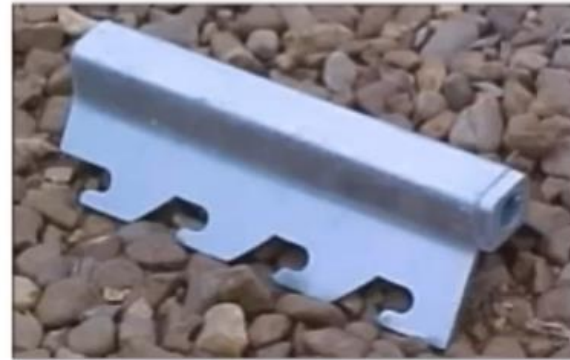
Cable Anchor Bracket

Universal Slotted
Rail Section

End Rail & Anchor Bracket
Interchangeable

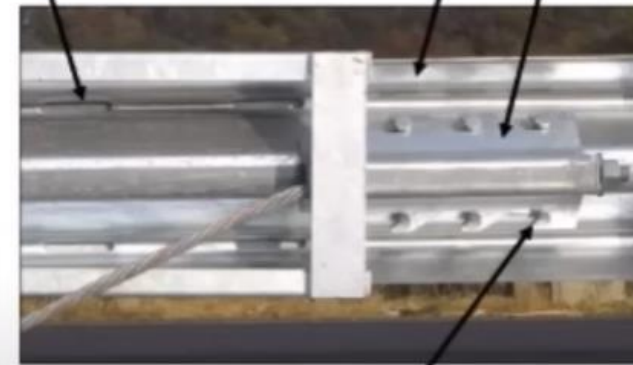
Special Shoulder Bolt (8 places)

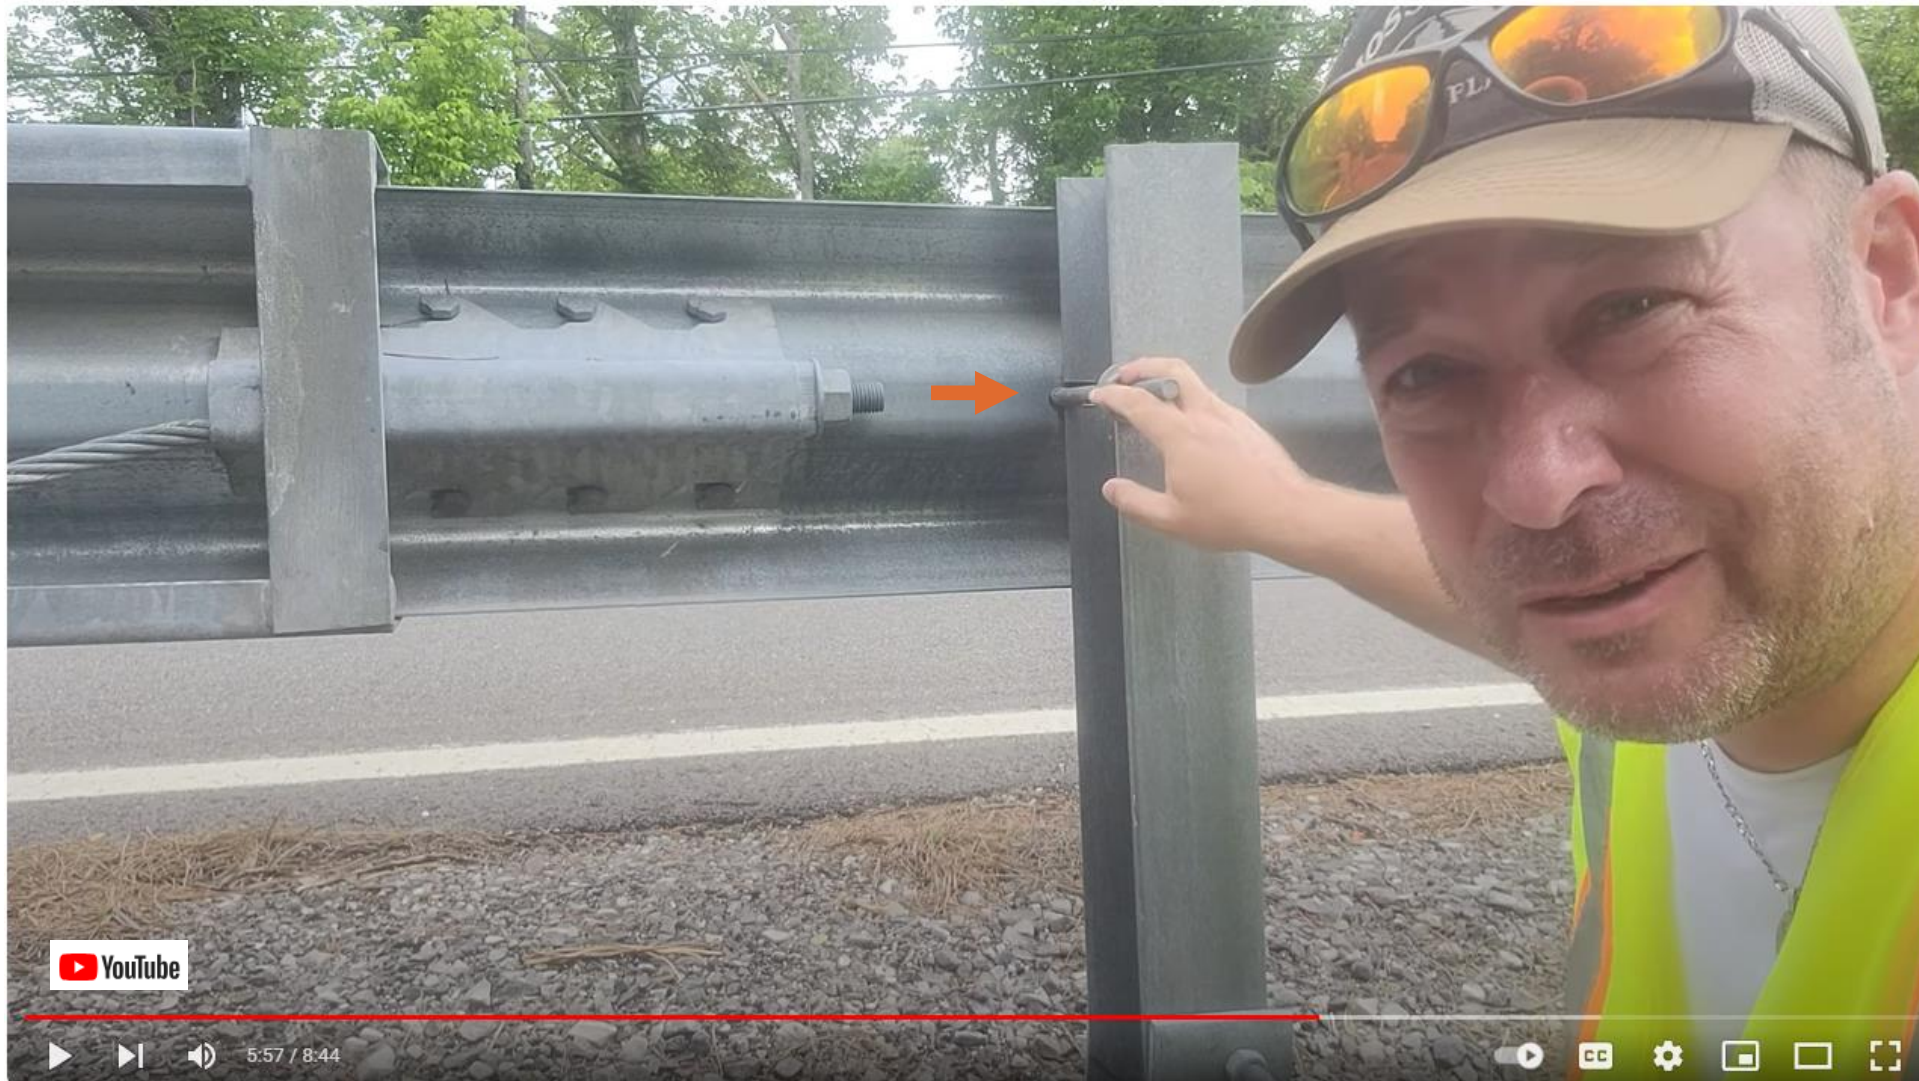
The long bolt will cause the extruder head to snag and stop

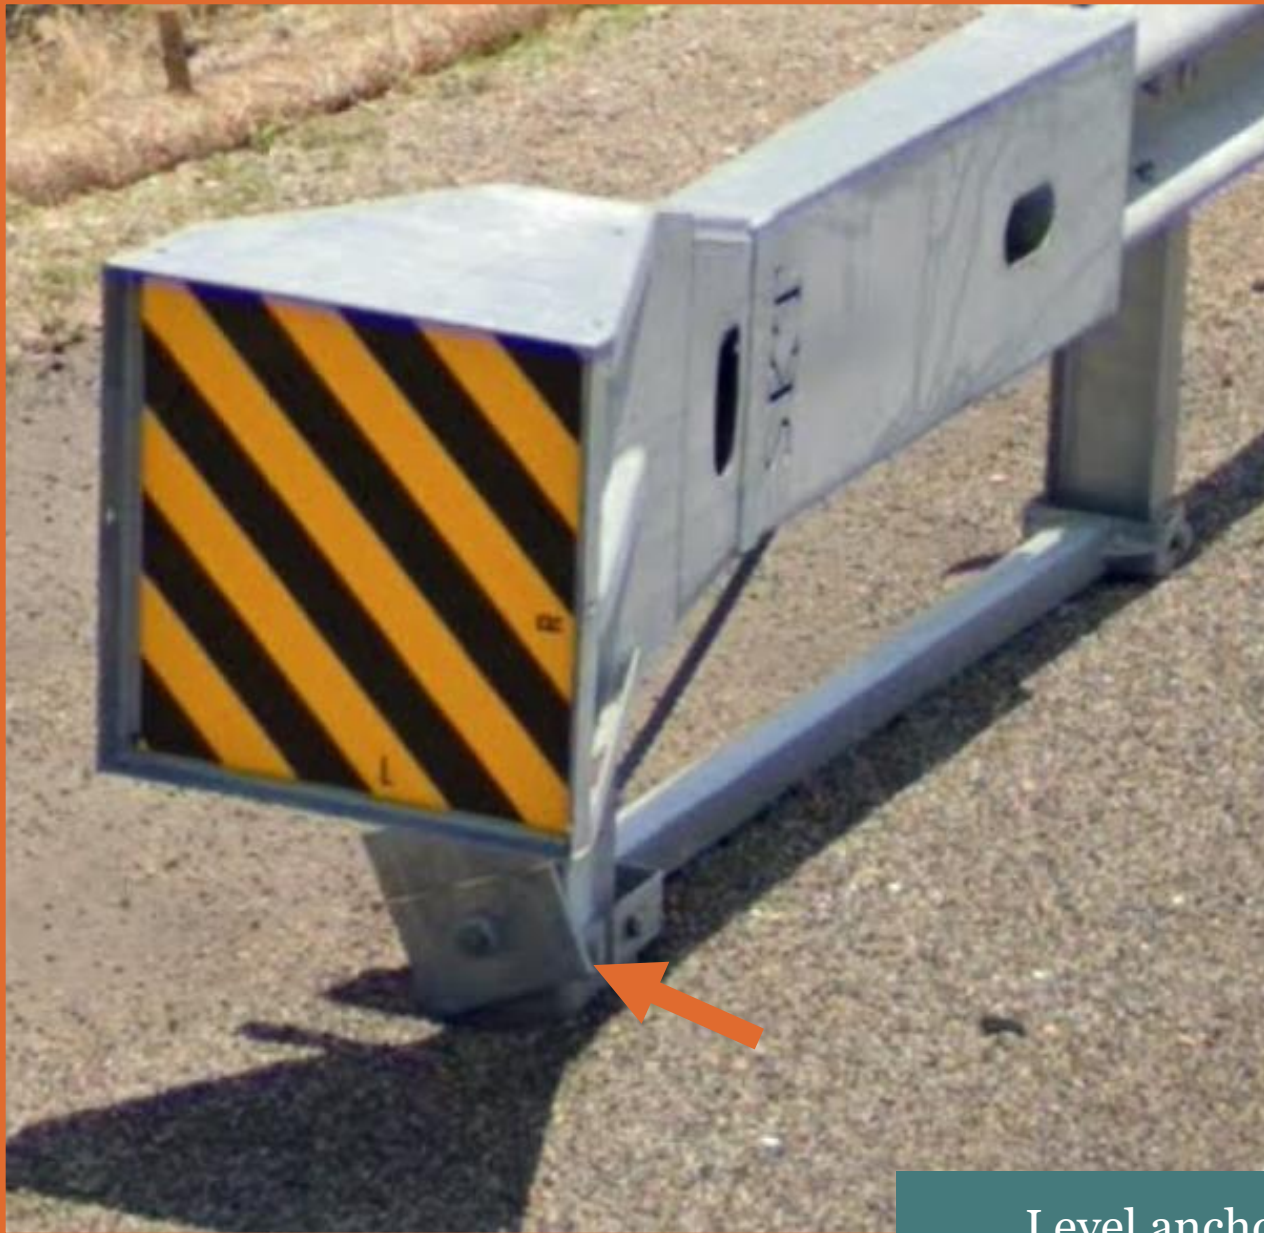
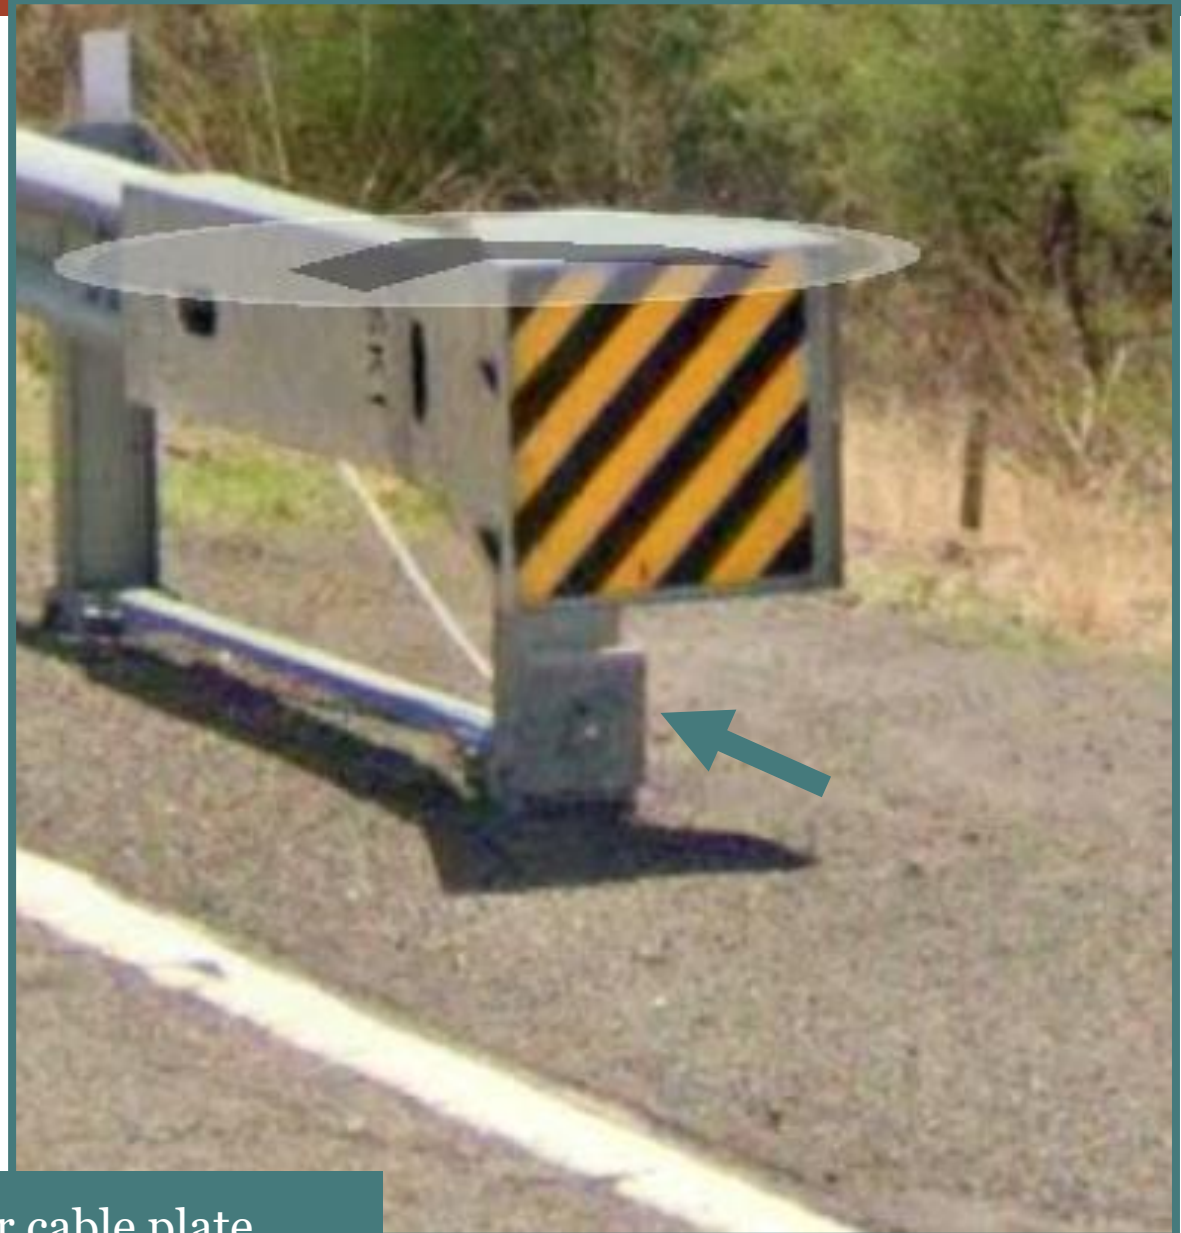
Google Maps also allows some aspects of improper installation or “Frankensteining” to be date stamped

What is wrong here?

Level anchor cable plate

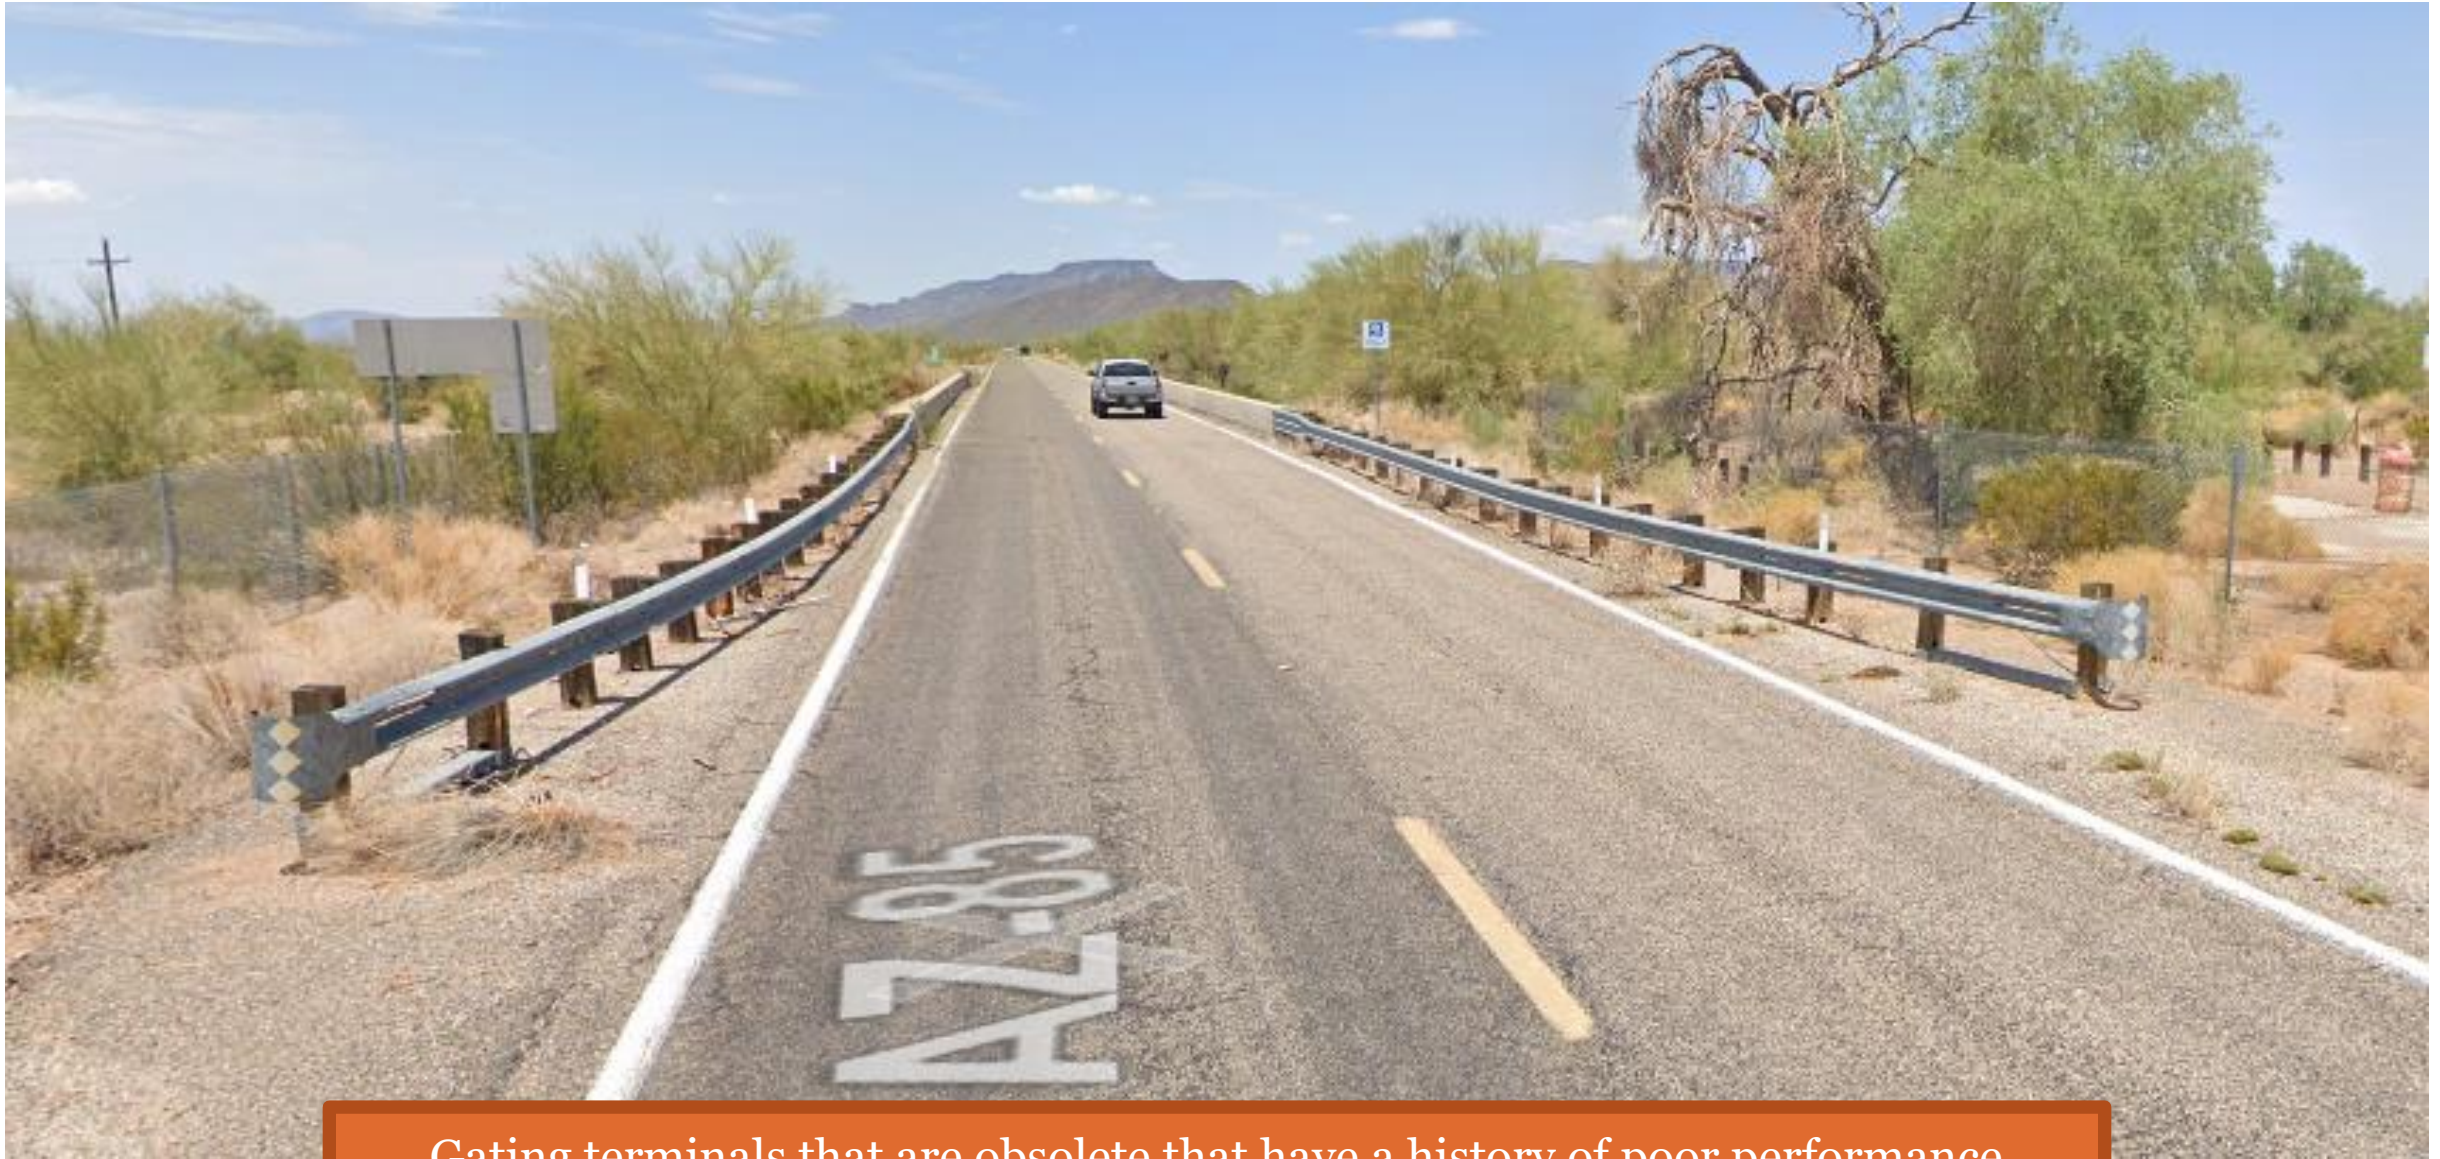
Gating terminals that are obsolete that have a history of poor performance
